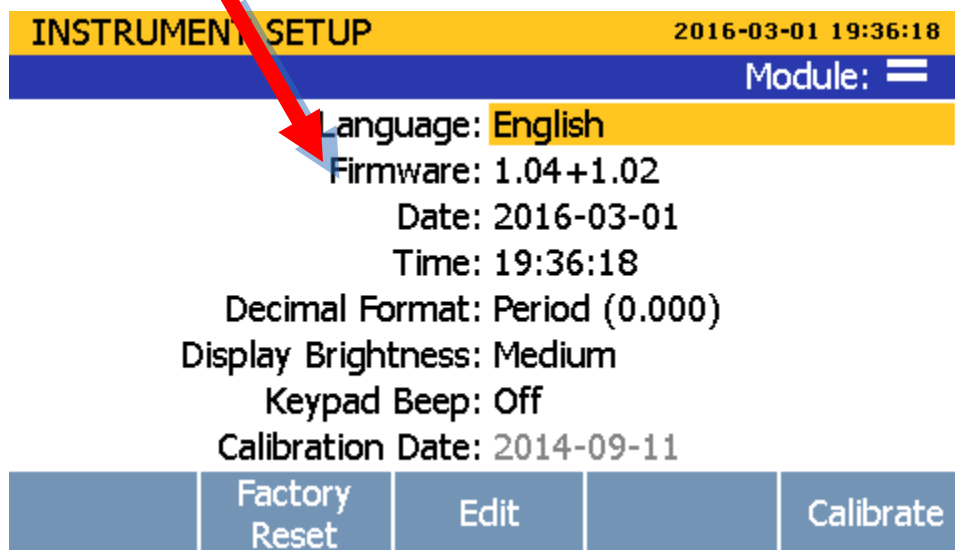
This notification affects all units with firmware version 1.03 or lower. To verify the firmware version press the **Instrument Setup** button then on the display the firmware will be listed.

If you have version 1.03 you can download the firmware update from our website.
